BUILDINGS AT RISK

Island's landscape reveals much of our social history

Frank Cowin, *Blue Badge Guide*, continues to share his views of things of interest and importance in the landscape - many at risk because they are not recognised, let alone protected.

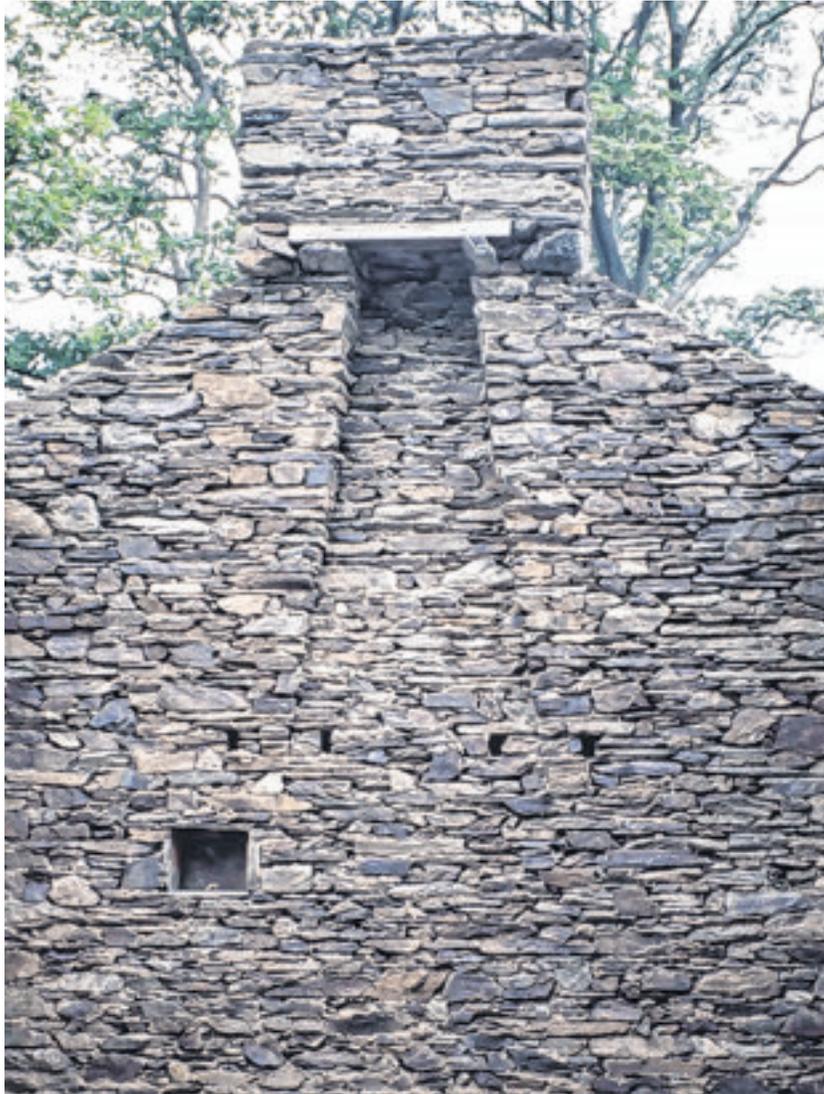
Glen Dhoo chiollagh (1998)

The house at Corody had a small smoke window at the side of the chiollagh, the kitchen fireplace, which in this case appears to have stretched right across the width of the house.

The chimney was a wattle and daub canopy taking the smoke up to a stone stack at roof level.

This is indicated by the bell shaped recess in the internal face of the wall which can be seen to good effect at a property in Glen Dhoo, Ballaugh.

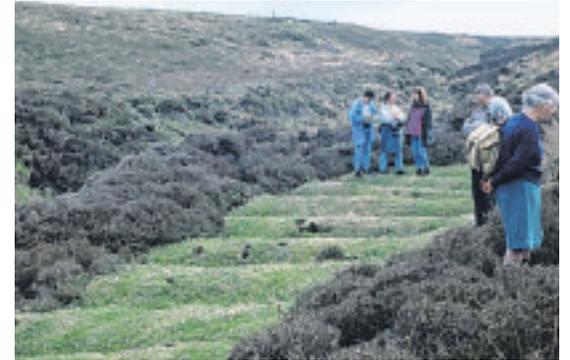
Lazy beds, Glen Rushen (1993)

The materials buildings were built of is a whole different story. Associated with many upland homes are 'Lazy beds'.

These are narrow areas for growing vegetables, herbs etc. for the table and the contents of the ashpit would be added to the beds each time the pit was emptied.

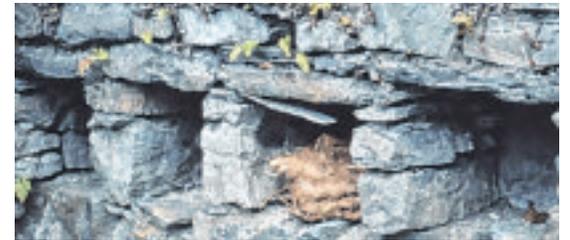
Bee boles (with straw Bee Skep), Kentraugh (2003)

'Bee Boles' are rectangular recesses in a wall or earth bank intended for the 'bee skeps', the plaited straw hives used in the past.

Ideally they would be sited so as to be sheltered from heavy frosts and from the height of the sun - either of which could kill off the bees.

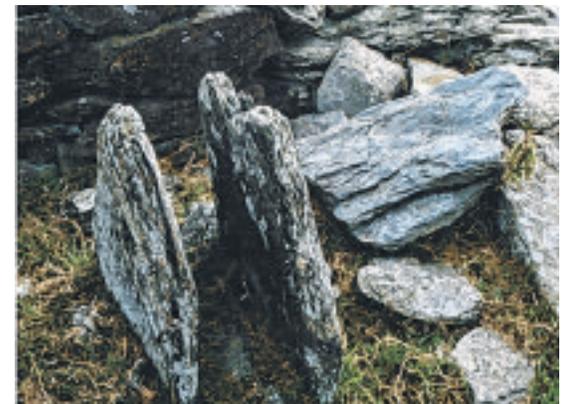
Grindstone supports at Corody (1992)

Immediately behind the house are two parallel standing stones of equal height, each with a notch in the top to receive the axle of the grindstone used to sharpen the tools.

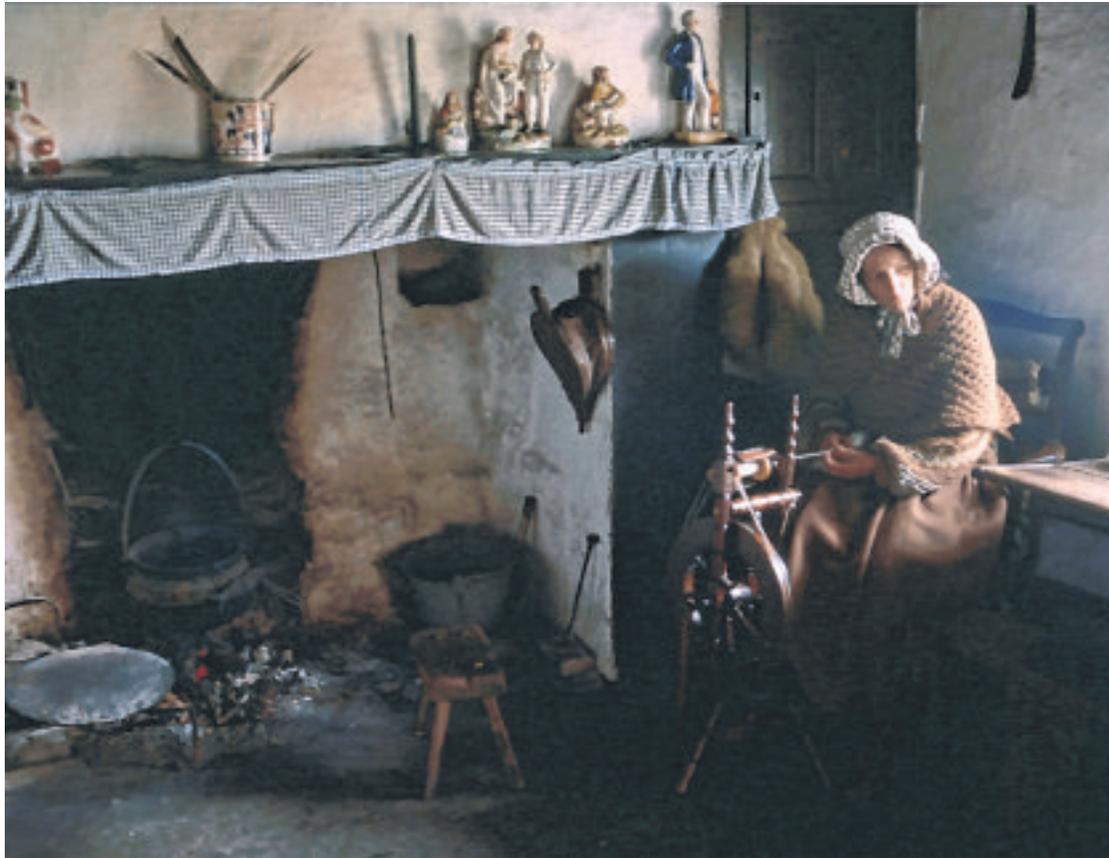
Chiollagh in Harry Kelly's cottage, Cregneash (1991)

This type of chiollagh and chimney is at odds with the general view that they are all like that in Harry Kelly's Cottage at Cregneash, which is more or less an indoor inglenook, with masonry side walls, a slate front lintel, and

a stepped chimney above.

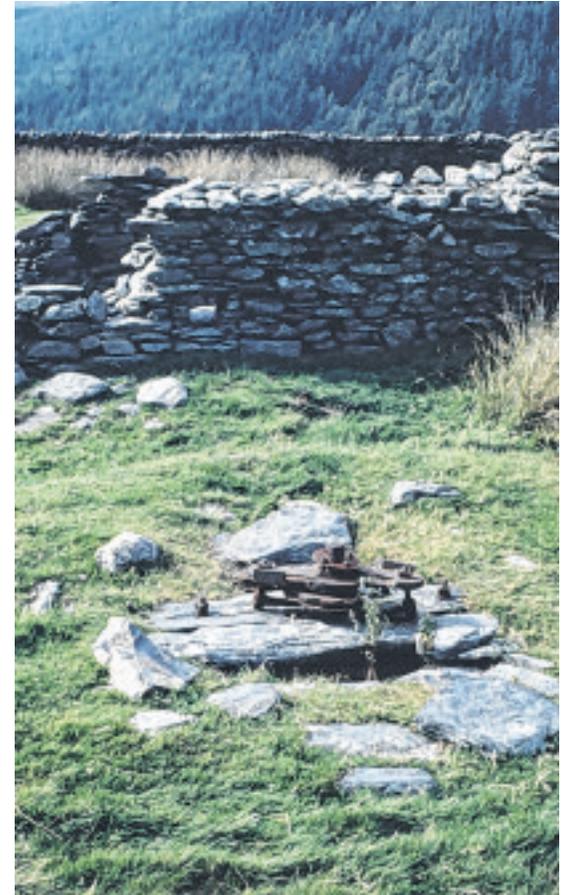
Corody horsewalk platform/mechanism (1993)

The remains of a small barn is abutted by a circular horse walk where in this case a single horse, or possibly cow, would walk in a circle to drive through beams and gears a threshing machine in the barn. One side of the raised horse walk extends to cover a poultry house - in this case

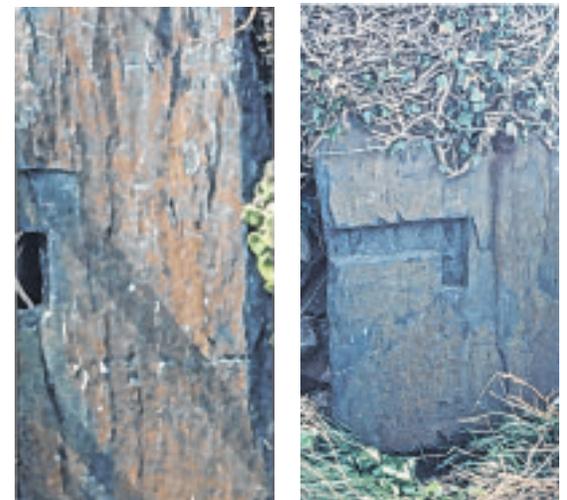
Pair of gateposts with holes and slots for wooden bars (1994)

Many 'estates' had individual styles for all their openings off the highway and even these are at risk, but most at risk are the older types one of which used individual bars, or with the bars fastened together to form a hurdle.

One post would be made of a slate slab with rectangular

holes formed in it whilst the other had corresponding 'key fret' recesses cut into the face. The bars would then be slotted into the hole and the other end run along the horizontal cut to drop into the downward cut of the fret pattern.
